Assessment of the Condition of Randomly Selected RCC Members of the Traditional Auditorium (Koothambalam Theatre) Kalakshetra Campus, by Non-Destructive Tests

Oct 2010

**Traditional Auditorium (Koothambalam Theatre)
of Kalakshetra Campus, Chennai.**

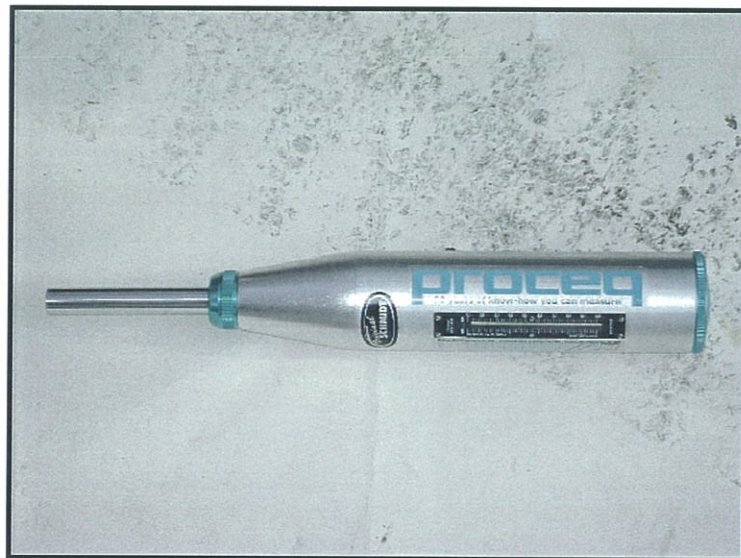
Fig.2 Rebound Hammer Instrument

Rebound hammers are available with different impact energy. The lowest energy rebound hammer (0.07 kgm) is being used for testing light weight concrete, the medium energy (0.09 kgm) is being used for normal weight concrete, and the highest impact energy (3.0 kgm) is used for testing concrete pavements / runways, etc., where normally higher size aggregates are used in the concrete. Though the working principle of the instrument is same for all types of rebound hammers, facilities for recording of RH values are provided in some of the types. The RH value can be directly read on a calibrated scale provided in the Center of the Hammer. Calibration Tables / Graphs are available with each type of Hammer, to estimate the compressive strength from the RH value, depending on the angle made by the axis of the hammer with the surface. The working principle of the Rebound hammer is very simple. When a spring loaded weight with a shaft is pressed against the concrete surface from its initial protruded position (rider reading 'Zero' on the scale provided on the hammer), the weight falls on the surface and rebounds carrying a rider along with it over the calibrated scale depending on the surface strength. The rider position is read, to record the Rebound Hammer Number/Value (RHV).

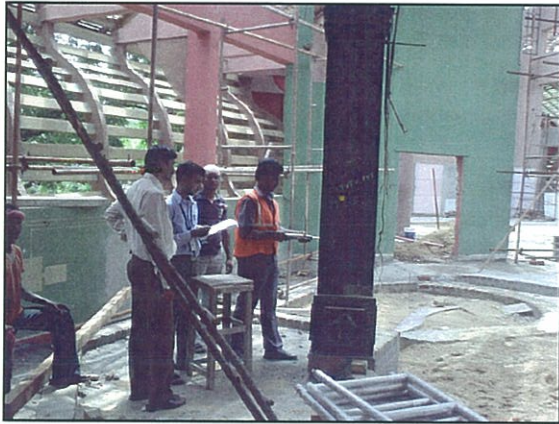
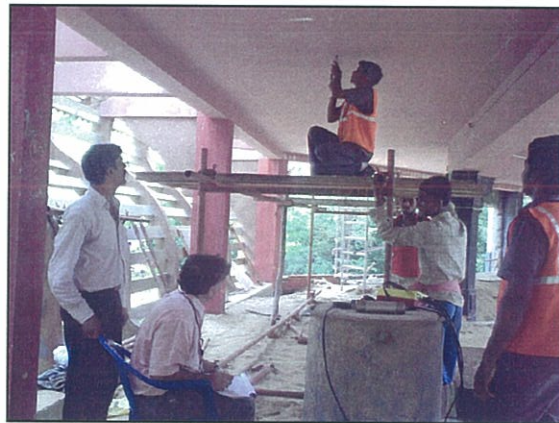
Fig. 3 – 5 Rebound Hammer Tests in Progress

Rebound Hammer Test was carried out on all the r.c.c. columns, beams and slab portions (balcony) that were identified by marking a uniform grid of 0.30m x 0.30m in either direction on the surfaces to assess the quality of in-situ concrete and very approximate strength (Reference chart "RH value versus Compressive strength" developed by testing large number of specimens in the laboratory) by measuring surface hardness. RHT was carried out at each grid point using PROCEQ N-type hammer, as per the guidelines of Indian Standard code of practice IS: 13311 (Part II) – 1992, and Rebound Hammer values were recorded in a separate data sheet, and later analysed. Fig.2 shows the instrument, and Figs 3-5 show RHT in progress on the identified structural members of the Theatre.

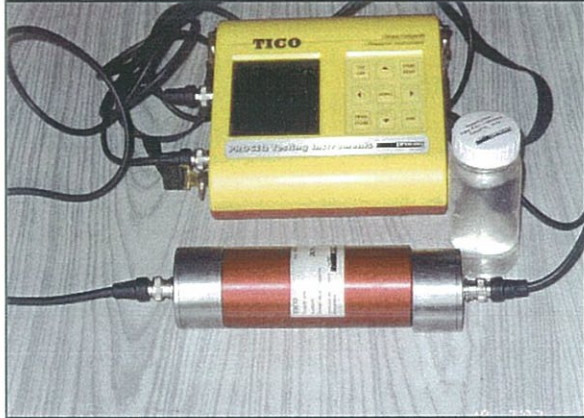
Fig. 7 Ultrasonic Tester

Ultrasonic Pulse velocity test using ultrasonic tester (in this case, TICO ULTRASONIC TESTER, (Fig.7) gives information on the integrity of concrete in the interior portions of concrete in the member. Presence of cracks, voids and other imperfections, changes in the structure of concrete, that occur with time, and the present quality of the concrete in relation to standard requirements could be determined from this test. Values of elastic modulus of concrete can also be determined by using the UPV values. In the present investigation, this test was conducted to determine the delamination zones of cover concrete, and voids/cracks in the interior of concrete, if any, etc.

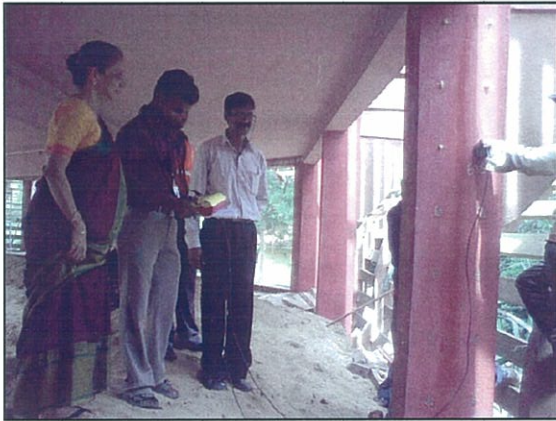
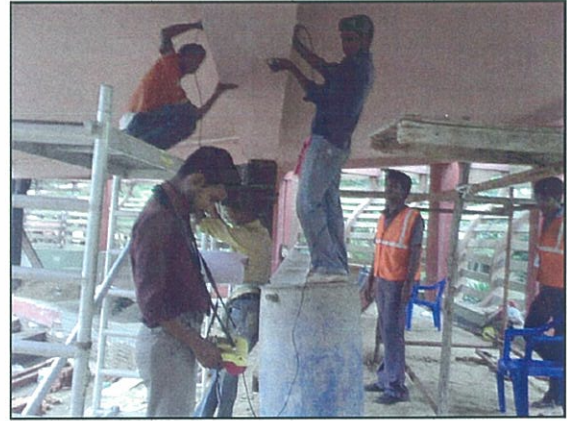
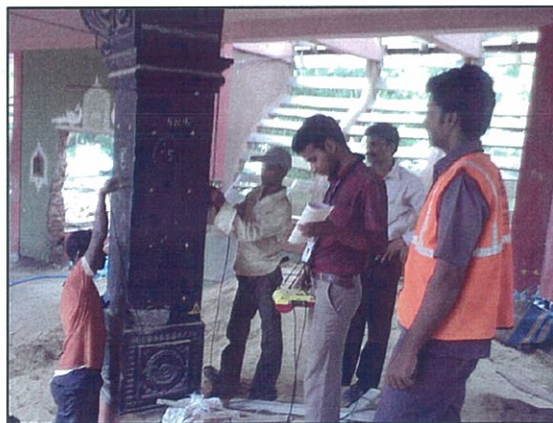
Fig. 9 – 11 UPV Test in progress

The points marked on the opposite surfaces earlier to line and level, for RH Test was used for this test also. Figures 9-11 show UPVT being conducted on the columns and beams. In this case also, the readings were taken over the plaster, and wherever delamination was observed, plaster was removed, and readings were taken. The difference in velocity with plaster and without plaster was very less due to good adhesion of plaster.
